Manhole Inspection Summary

Manhole # S63A1_004MH

Insp Date: **3/5/08 9:28 AM**

Location Address: **2220 Vail St.**

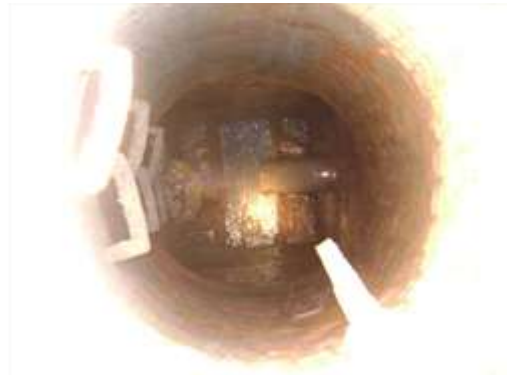
Top View

Comments **DROP CONNECTIONS ARE PARTIALLY CLOGGED AND CLOGGED. STRUCTURALLY THE MANHOLE IS IN "GOOD" CONDITION. CLOGGED DROP CONNECTIONS MAKE THIS LOOK WORSE THAN IT IS.**
